Coastal Management For Traditional Villages Community of Newcomb

Inland Stormwater Management,
Shoreline Investigation and Retrofit
Project Recommendation

September 2011

**Talbot County Office of Planning
and Zoning**

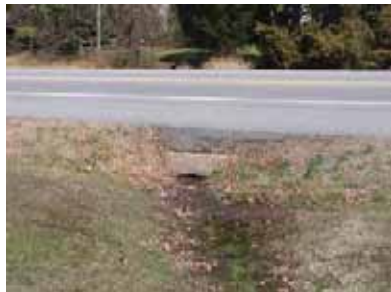
Photo 63

The most noteworthy item discovered from the field investigation was that a majority of the driveway and cross culverts were clogged between 50-75% with sediment. This factor of clogged culverts and minimum slopes in ditches results in extended ponding or flooding in the low lying areas.

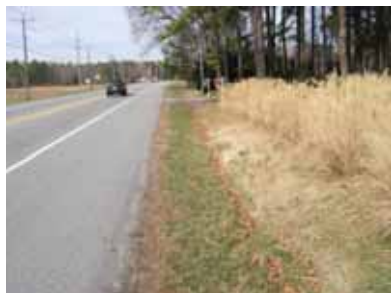
*Photo 27
(St. Michaels Road)*

The roadside drainage ditches are typically usually 1-2' deep, and in the case of the ditch system along Royal Oak Road, the ditch was a minimum of 2.5' up to 3.5'. Ditch bottom widths range from 6-12". The Royal Oak Road ditch system is located immediately off the driving lane. Some evidence of pavement failure is evident along the ditch system. Ditches near or under trees are filled with leaves and other debris. River and Woodside Roads have shallow parabolic grass swales that are approximately 6" deep. The drainage system along the St. Michaels Road (Rt. 33) is located off the road's shoulder on each side and tends to have milder side slopes, roughly 4:1 or less, as is typical with most State roads. All drainage ditch systems discharge into the Miles River or Oak Creek without any stormwater management devices in place.

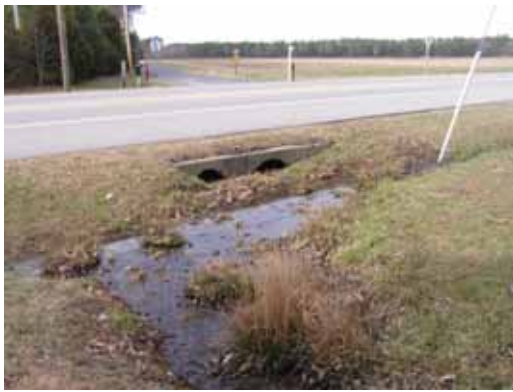
Photo 38

Miles-1 is a 660' long, tree-lined trapezoidal-ditch that flows northeast from St. Michaels Road towards the Miles River (Photos P39 – P41). Twin culverts crossing St. Michaels Road, in which are 50% clogged, pass the runoff from the south (Photo P38). The ditch transforms into a wide floodplain channel before discharging into the river (Photos P42 – P44). The floodplain is a tidal area. The ditch is approximately 2' deep and appears stable. However, as evidenced from a fallen tree that was identified along the ditch, it appears the ditch cannot handle the volume of water from large storm events.

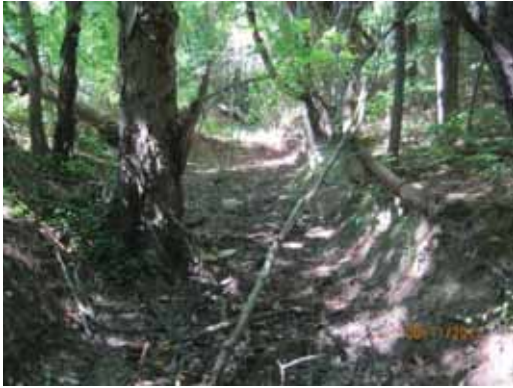
Photo 136

OAK 4 is a 1,180' long drainage channel that begins at Royal Oak Road and continues to Station Road. As listed in Table 1, OAK 4 is the focal drainage point of approximately 102 acres. A cross culvert discharges runoff into the channel from the western side of Royal Oak Road. The channel begins in a wooded area (P135 - P138) and then continues into an open space (P097 - P098). After the open space, the channel turns sharply northeast and then east towards Station Road. After crossing Station Road in a 30" CMP culvert, it discharges into a large tidal channel off of Oak Creek. The channel has consistent cross section for its entire length between Royal Oak and Station Roads, including a 5' bottom width, 3-4' deep, and 1:1 side slopes. Some trees and limbs have fallen into the channel. After Station Road, the channel passes the historic cemetery and two private sheds that are constructed right upon the banks of the channel (P081 - P089).

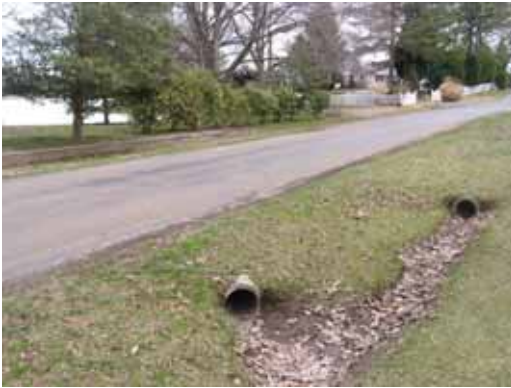
Photo 103

OAK 5 is an outfall culvert that receives runoff from River Road. Two culvert pipes and a roadside swale drain towards the outfall culvert. Although the downstream of the pipe was identified, the upstream side was not visible (P103 - P104). The outfall pipe discharges through a deteriorated timber bulkhead (P105) where significant washout is evident (Photo 105A). In observing the elevations of the pipe's downstream invert compared to the estimated upstream invert, it appears the pipe has a negative slope. Outfall pipe and bulkhead are in disrepair.

OAK 5 is a location where the drainage area is relatively small (7.5 ac.), however the existing pipe that is the outfall for the upland area is buried and needs to be replaced. A small 80' long Submerged Gravel Wetland (SGW) is proposed in-line with the existing roadside ditch. This concept plan proposes to remove, replace, and relocate the old outfall pipe with a new one. The new outfall pipe would discharge into a stone plunge pool as part of a living shoreline concept proposed at this location (see *Shoreline Improvement Recommendations*). According to the residents, a 50' wide County Right-Of-Way exists on the north side of River Road near the River Road/ Woodside Road intersection. This ROW was established to allow fire trucks to access Oak Creek for water withdrawal. The new outfall pipe would be located in this unpaved ROW area. ***Exhibit 7*** shows a conceptual plan view and profile of OAK 5.

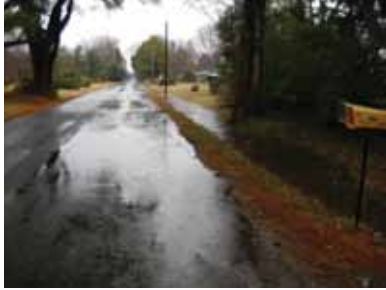
Station Road, Facing Northeast

During the course of gathering information for this study, residents of Newcomb were invited to provide feedback on the conditions of the Village, specifically any problem areas of flooding or erosion. A majority of the residents interviewed mentioned the biggest problem is the flooding that occurs at the intersection of Station Road and Royal Oak Road. There are roadside ditches on both sides of the two roads; however, the problem occurs, according to the residents, in the downstream ditch along Royal Oak Road. There is a residence located 190' to the north where their driveway culvert is clogged. This blocked culvert causes backup to the intersection and further up Station and Royal Oak Road. The residents state that flooding regularly encroaches the road, creating a driving hazard. One resident, Mrs. Julie Imirie, stated the problem causes a residual effect of flooding her property. This roadside ditch (on the northbound side) receives runoff from as far south as Acorn Road. In all, the area draining to this roadside ditch is roughly 17 acres (DA14 and DA17). The 2-year storm produces approximately 12.8 cfs. If the roadside ditch was free and clear of debris, it would be able to contain this flowrate with a peak velocity of 2.4 feet/second. The following are pictures provided by Ms. Imirie and AMA.

The issue of the Royal Oak Road / Station Road intersection flooding during storm events is discussed in the section *Community Input*, above. Due to the pressing concern that this flooding is currently a driving hazard, the County should promptly proceed with installing a new driveway culvert at the residential property located on Royal Oak Road. The field inspection revealed that the remaining culverts leading to the large channel are free of debris. Installing this single culvert should rectify the flooding problem at the intersection.

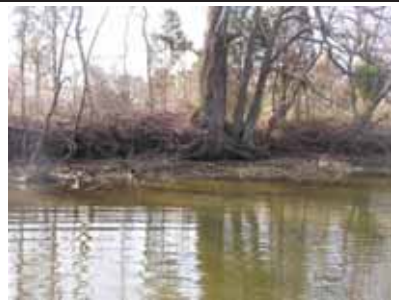
3	315'	Natural - Wooded	Unstable

<p>Photos: W31 – W34</p> <p>Remarks: Natural shoreline is mud flat beach with sparse trees and heavy vegetation. Some scouring and tree roots apparent. Area is secluded thus it is anticipated that erosion is caused by either rainfall or refracted waves from adjacent bulkhead.</p>				
4	170'	Bulkhead / Stone Revetment	Stable

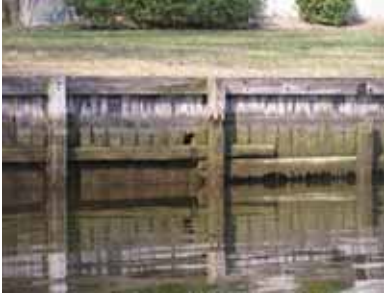
8	120'	Old Timber Bulkhead	Moderately Unstable

<p>Photos: W63 – W67</p> <p>Remarks: Aged bulkhead in need of replacement. Openings between timber sheeting boards evident. At time of investigation, water was draining from hole in bulkhead (shown in picture). Pipe visible in hole (Photo 67). OAK 5 daylights through bulkhead. Area behind OAK 5 is washed out (Photo 103 & 105A).</p>					
9	265'	Natural - Vegetation	Moderately Unstable

Section 8 is a bulkhead that has reached the end of its service life. As mentioned in Table 11, the openings between the sheeting boards have expanded over the years. This expanded opening is an avenue for sediment loss. The County can provide recommendations and guidance to the property owner for bulkhead replacement.

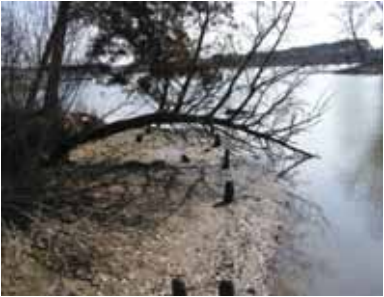
<p>Photos: W68 – W73</p> <p>Remarks: Small peninsula and mud flat area with a natural shoreline. Broken piles are evident around perimeter of peninsula, indicating possible bulkhead existed here at one time. Elevations on peninsula are high enough to support upland evergreen trees. Peninsula transforms into a mud flat area which is the outfall of OAK 4 (Photo 73).</p>					
10	75'	Make Shift Bulkhead	Moderately Unstable

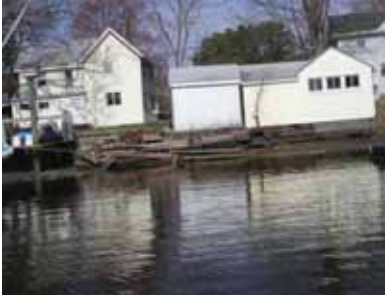
<p>Photos: W74 – W75</p> <p>Remarks: Make shift bulkhead made from various sized and located boards. Sheds/buildings located directly behind bulkhead.</p>

Section 10 is a make-shift bulkhead which is directly outboard of three small buildings. Although the bulkhead currently appears stable, it is expected that this structure will not endure. It is recommended that this structure be replaced with a typical bulkhead structure of pilings and sheeting.

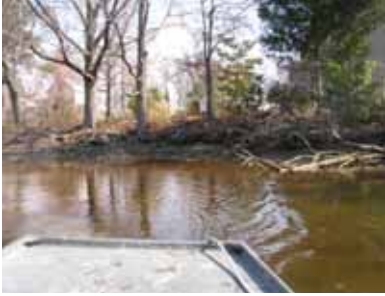
11	280'	Natural - Wooded	Unstable

<p>Photos: W76 – W77</p> <p>Remarks: Natural shoreline covered with sparse vegetation and trees. Limbs and minor scouring are evident on northwest side of cove. Mud flat outfall of OAK 3 is located before scoured shoreline. Area is secluded thus it is anticipated that erosion is caused by either rainfall or refracted waves from nearby bulkhead.</p>

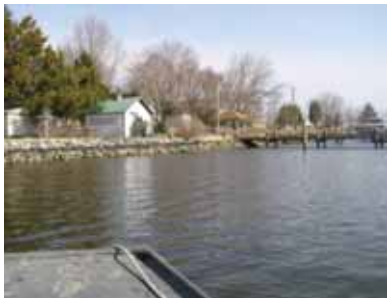
<p>Photos: W78 – W85</p> <p>Remarks: Mostly stone revetment shorelines with small section of timber bulkhead. With the exception of one area at the before timber bulkhead begins (Photo 81), all structural shoreline appears stable.</p>				
13	400'	Steel / Timber Bulkhead	Stable

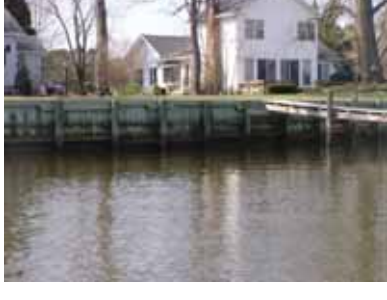
Photos W106 (Bulkhead) and W105 (Outfall of MILES 3).  			
17	380'	Stone Revetment	Stable
Photos: W110 – W111 Remarks: Tall stone revetment protecting two residences. Stone revetment ends at outfall of MILES 1.

<p>Photos: W96 – W109</p> <p>Remarks: Timber bulkhead of various ages. Appears bulkheads have been sporadically replaced over the years. Some sections are recent construction. 165' of bulkhead fronting new construction at end of Beach Av. is in state of disrepair (Photos W106). This is the outfall location of MILES 3 (Photo 105). Sand accretion is apparent in front of some bulkhead sections.</p>

The 165' of bulkhead located near Beach Avenue is in state of disrepair and should be replaced. It is recommended that this project coincide with the implementation of MILES 3. The remaining 1,500' of bulkhead is in good condition.
