COASTAL MANAGEMENT FOR TRADITIONAL VILLAGES: ROYAL OAK ASSESSMENT

Prepared by the Center for Watershed Protection, Inc.

Prepared for Talbot County Office of Planning and Zoning

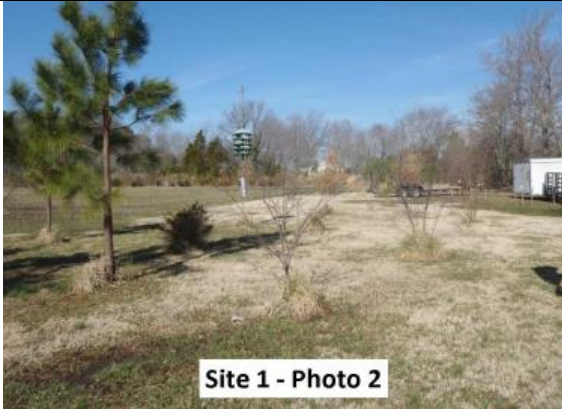
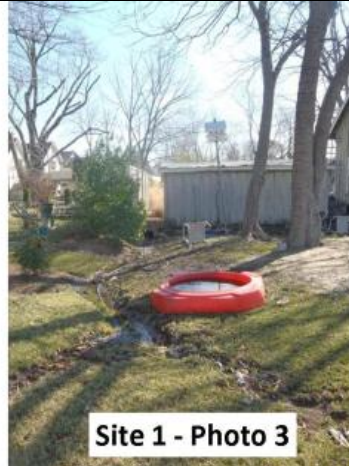
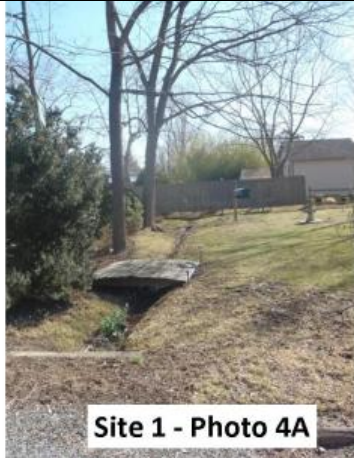
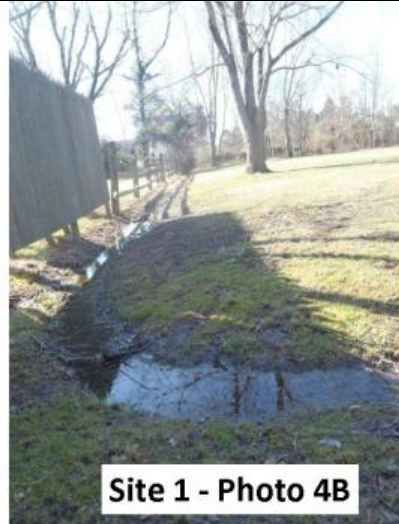
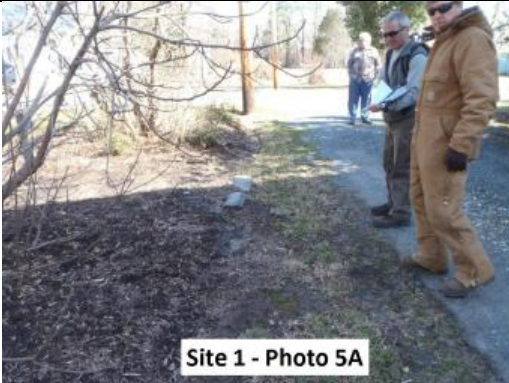
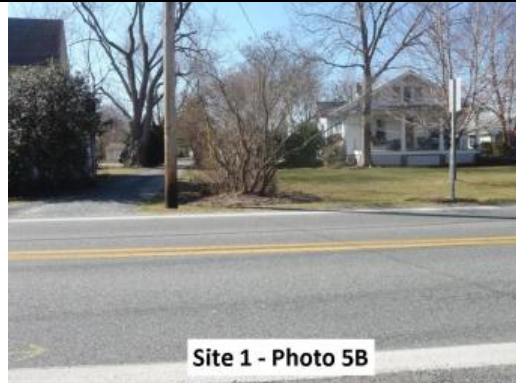
Table 2. Site 1 field photos.

1. The first starts with field runoff conveyed in a shallow depression (Photo 1A) that feeds a small ditch that runs the perimeter of the Fox property (Photo 4B) before entering a pipe system (Photo 4A).
2. The second collects the runoff from the field in small ditches immediately adjacent to the downstream side of the vegetated buffer and conveys runoff to a small pipe system (12” plastic pipe in background of Photo 3).

- The pipe systems indicated in Photo 3 and 4A connect at 180 degrees with no maintenance access;
- The area circled in Photo 5A: this is a pipe connection of what was previously an open ditch; this area is a low point between the driveways and Royal Oak Road that routinely ponds water and the surface condition indicates that water enters the pipe system through the ground, likely carrying a significant volume of sediment into the pipe;

- The outfall of this system is shown in Photo 8 & 8A, and is in disrepair. The last pipe section has separated and fallen into Oak Creek. Rip rap and other construction debris was periodically placed around the outfall to stabilize the bank and outfall pipe.

1. Install a manhole, inlet, or access structure at the 180 degree connection (structure 1 in Figure 5). Since this is a small system on private property, it is likely a homeowner installation.
2. Install inlet structure at location identified in Photo 5A (Structure 2 in Figure 5). Investigate the condition of pipe in both directions. Possible video of pipe under Royal Oak Road will help identify potential drainage problems associated with the State highway (or county) system in Royal Oak Road, and possibly locate the alignment of the system on the north side of Royal Oak Road. The owner of Property A indicated that he would install this junction since he had previously made the connection.
3. Install maintenance access (or cleanout) at the 90 degree bends in the system on the north side of Royal Oak Road.
4. Repair outlet of pipe system at Oak Creek.

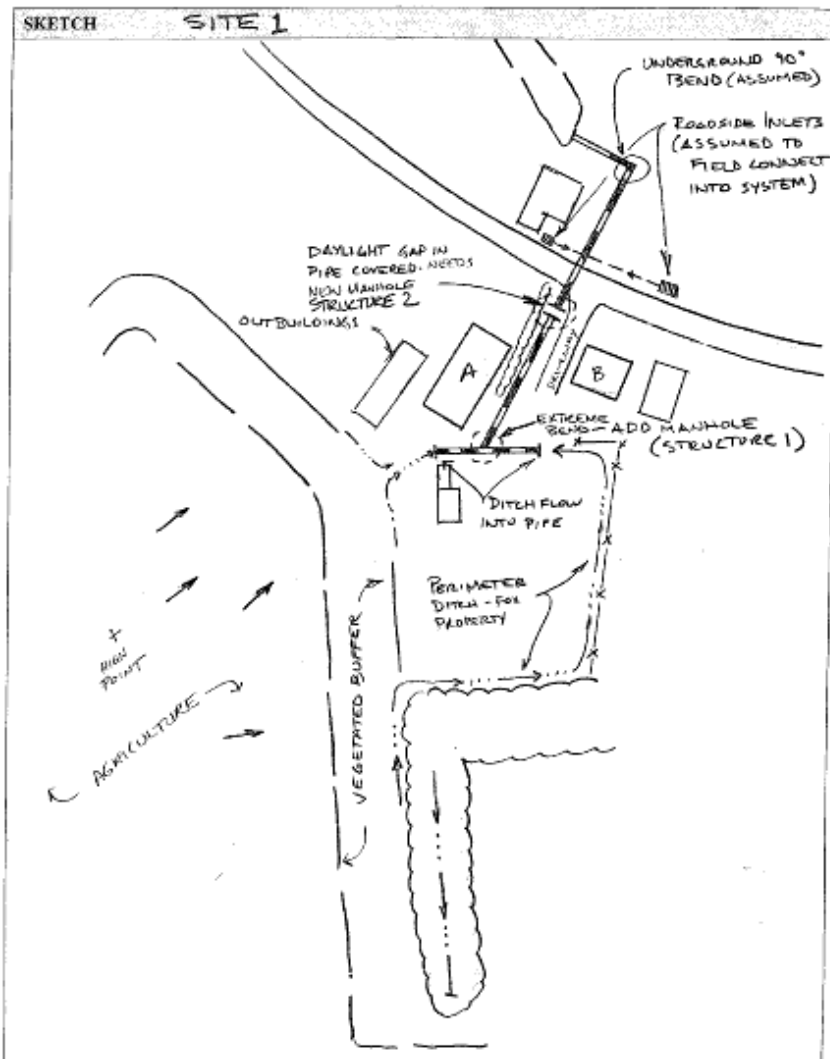
Figure 5. Site 1 system was sketched from field work and includes drainage inlets serving Royal Oak Road.

There are no as-built stormwater drawings to verify the configuration of the pipe system below this point. Figure 5 provides a best estimate of the system including drainage inlets serving Royal Oak Road. It is important to note the following:

- Inlets on Royal Oak Road (one in each direction – east and west) field connect into this system at an undetermined location without any maintenance access;

- The pipe system continues across Royal Oak Road and makes at least two 90 degree bends (vicinity of Photo 7) without any maintenance access, before discharging into Oak Creek. (Construction of a sewer connection from the house on the north side of Royal Oak Road indicated no conflict with, or evidence of, the drainage system; and

Recommendations to alleviate flooding include:

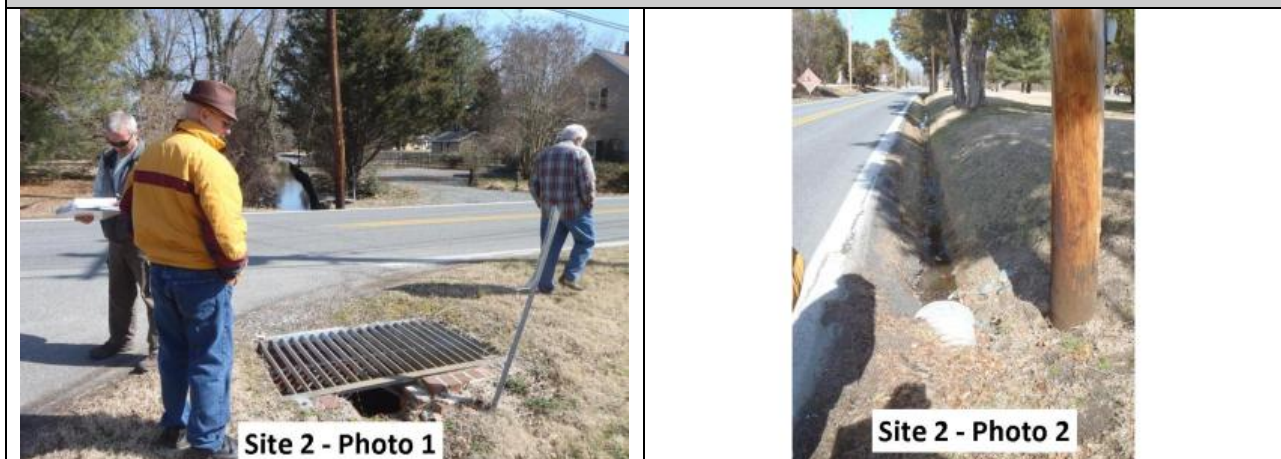
Table 3. Site 2 field photos.

Photos 2, 3, 4 and 5 show inlet pipes that connect to a large grate inlet (Photo 1), however, since only 3 incoming pipes were observed, there is likely an alternate alignment. Also, along the alignment of the pipe depicted in Photo 3 is a connection of another 15 inch diameter pipe and since no junction box is evident, it is assumed that this is a field connection. A more thorough investigation of these systems is required in order to evaluate if there is any drainage system upgrade or reconstruction required. It should also be noted that the entrance of the 18 inch CMP pipe on Thorneton Road is crushed (Photo 5).

Finally, the invert of the primary culvert under Royal Oak Road, a 32 inch by 48 inch (approximate) horizontally elliptical corrugated metal pipe (HECMP), is rusted out at the outlet and may begin to undermine the outlet and the road embankment if not repaired. The outfall channel appears to be stable and is held on one side by a bulkhead.

1. Verify the location, alignment, and condition of the pipe system serving the intersection of Thorneton and Royal Oak Road;
2. Identify any pipe junctions that are without an access manhole or junction box; and
3. Clean out the entrance of the culverts and verify the working condition of the pipes.

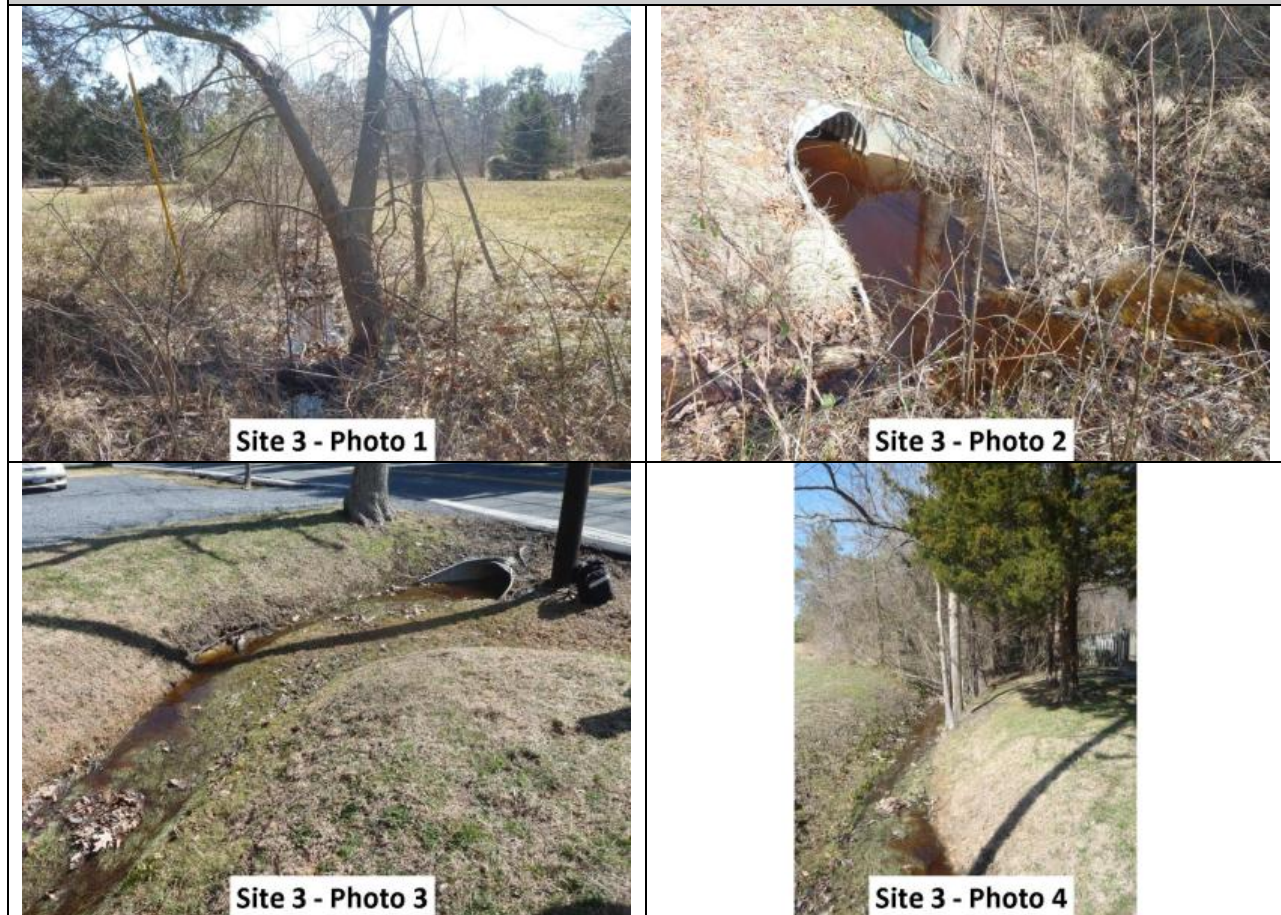
Table 4. Site 3 field photos.

The upper portion of the contributing drainage shed to the cross culvert consists of forested wetlands. Closer to the road, the area is clear with a small the drainage consisting of a small shallow channel with thick vegetation (Photo 1). The area where the flow enters the roadway culvert is well maintained (clear of woody vegetation) and the culvert itself is in good condition (Photo 2).

The roadway culvert includes a field connection. The driveway on the east side of the culvert outlet (Photo 3) has a small culvert that connects directly into the roadway culvert approximately three feet upstream of the outlet. This driveway culvert connects one of the four roadside ditches that connect to this channel – two on the upstream side and two on the downstream side. The reports of periodic flooding over the roadway may be the result of the hydraulics caused by the field connection as well as the hydraulics of the contributing ditches; although the issue of potential channel erosion below the culvert (Photo 3 & 4) is more of a concern than flooding.

There are no obvious retrofit opportunities or fixes to this system of ditches and the cross culvert. The ongoing management practice of maintaining this area as a close-cropped lawn is contributing to the erosion. The area of channel now currently experiencing erosion may benefit from minor stabilization with biodegradable matting and vegetation. The plantings appropriate for this area should be relatively strong rooted ground cover rather than a bushy or thick shrub that would restrict the flow in the channel.

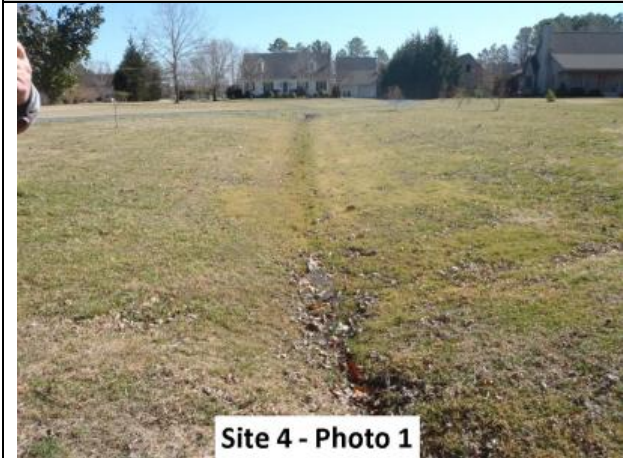
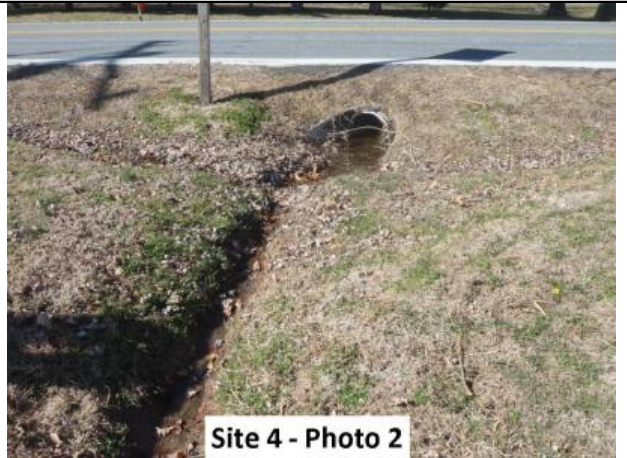
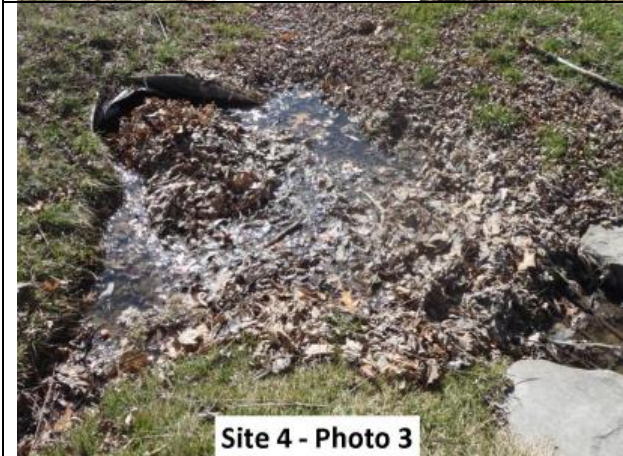
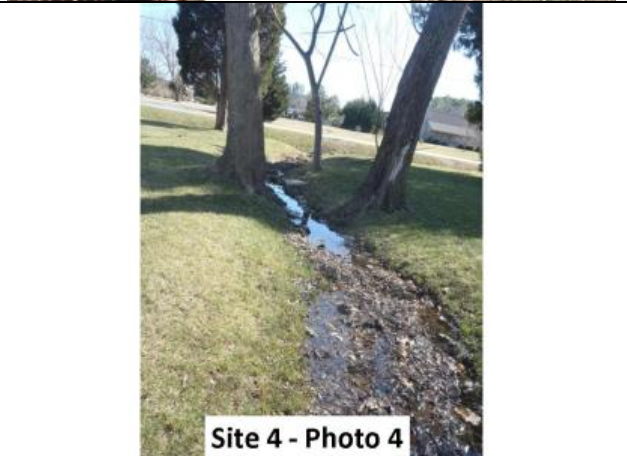
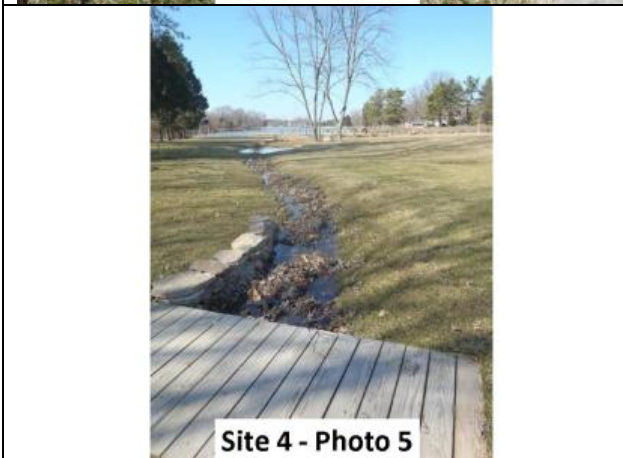
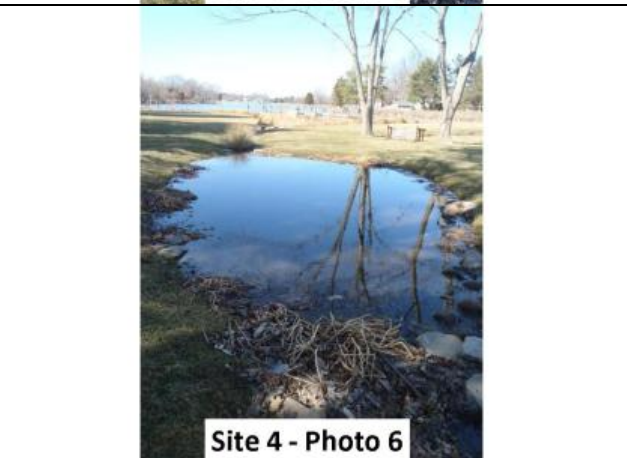
Table 5. Site 4 field photos.

The upper drainage area to the roadway cross-culvert consists of managed lawn. A broad flat swale gradually becomes more defined as it approaches the culvert (Photo 1 & 2). Typical for roadway culverts in the area, there is very little headwater depth available for the roadway cross-culvert to carry large storm flows. Therefore, the water is likely to back up during large storms and overtop the road. Also, this could occur in smaller storms (e.g., < 1 inch rainfall) if the culvert becomes clogged with leaves or debris (Photo 3).

The upper portion of the channel (upgrade) – south of Royal Oak Road (Photo 1), could be retrofit with a shallow bioretention area to help reduce nutrient loads associated with managed turf in the upper drainage area, thereby improving the aesthetic conditions of the existing landscape pond. The proposed shallow bioretention area could consist of a heavy planting of herbaceous, local vegetation and include a six inch ponding area with a permeable berm. The permeable berm is proposed in lieu of an underdrain since there is no option to “daylight” an underdrain due to the flat grades.

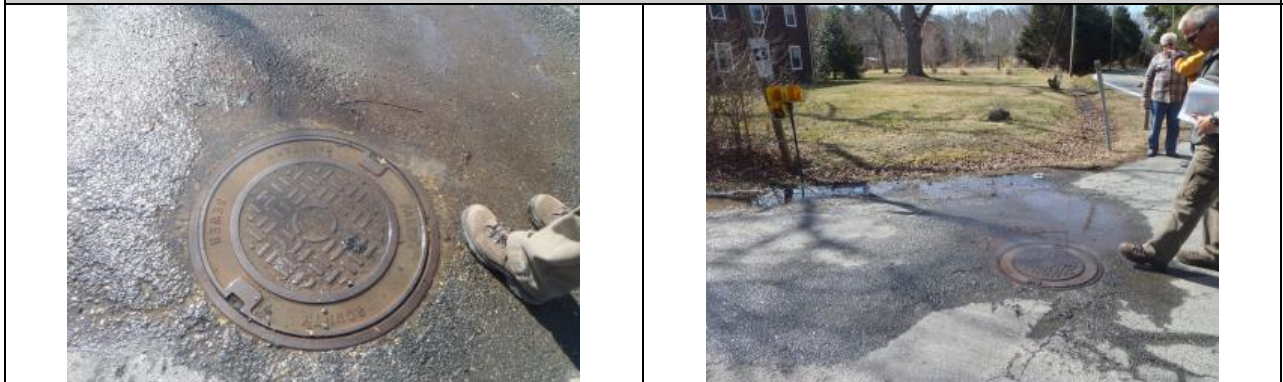
Table 7. Hot Spot investigation field photos.

A manhole that covers the pump station overflow was found in the field. This Hot Spot (Site Number 100) was located on the corner of Schoolhouse Lane and Royal Oak Road (38° 44' 28.23" N, 76° 10' 9.09" W). The site is indicated in Figure 3 with a red box. The overflow was documented (Table 7) and phoned into Talbot County Planning and Zoning Division. The City of Saint Michael's waste water treatment staff investigated this within hours of the original identification. Groundwater infiltrates the well, rises, and comes out of the manhole. It was tested that afternoon and contained no evidence of sewage contamination. This site often overflows according to the Royal Oak residents.
