Coastal Management For Traditional Villages Community of Newcomb

Inland Stormwater Management,
Shoreline Investigation and Retrofit
Project Recommendation

September 2011

**Talbot County Office of Planning
and Zoning**

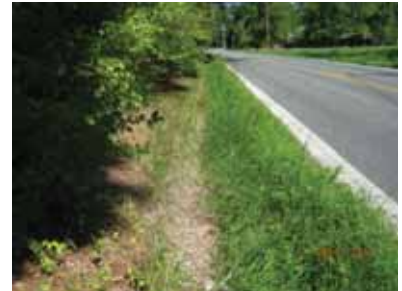
Photo 126
(Royal Oak Road)

The roadside drainage ditches are typically usually 1-2' deep, and in the case of the ditch system along Royal Oak Road, the ditch was a minimum of 2.5' up to 3.5'. Ditch bottom widths range from 6-12". The Royal Oak Road ditch system is located immediately off the driving lane. Some evidence of pavement failure is evident along the ditch system. Ditches near or under trees are filled with leaves and other debris. River and Woodside Roads have shallow parabolic grass swales that are approximately 6" deep. The drainage system along the St. Michaels Road (Rt. 33) is located off the road's shoulder on each side and tends to have milder side slopes, roughly 4:1 or less, as is typical with most State roads. All drainage ditch systems discharge into the Miles River or Oak Creek without any stormwater management devices in place.

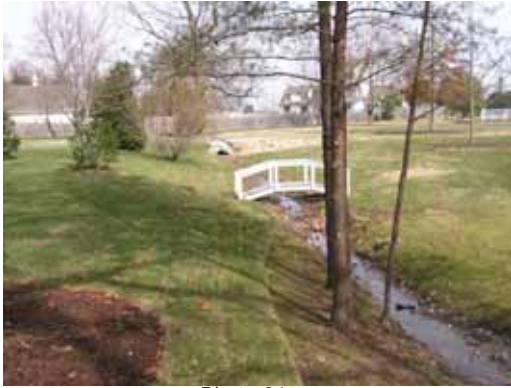
Photo 31

Miles-2 is a series of three different channels. The first channel is a 290' long, stable, trapezoidal grass channel which receives runoff via roadside ditches from both sides of St. Michaels Road (P027 – P031). A large riprap apron is located on the downstream side of the culvert cross Rt. 33 and prior to the grass channel. The grass channel leads into a wide riprap channel with a grade stabilizing wall on one side (P037). After the vertical walls ends, the riprap channel continues towards the river. Riprap is evident on the channel's bottom. Side slopes are mild with grass cover (P034 – P035). The runoff is discharged into the river via culvert through the timber bulkhead (P036). All channels appeared to be stable.

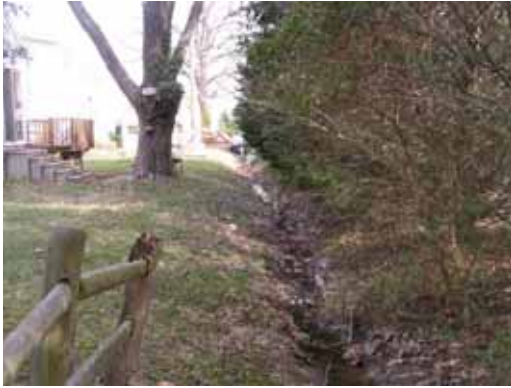
Photo 23

MILES 3 is a 750' long, narrow and shallow trapezoidal ditch that bisects residential properties near Beach Road. Standing water was noticed at the upstream end of the ditch where it crosses Rt. 33 (P021 - P023). A residential house was being constructed at the time of the investigation. The house is within 6' of the ditch. Several roof drains discharge into the ditch. The ditch flows into a culvert and then through the bulkhead into the river (P024 - P026). There were some signs of scouring on the side slopes of the ditch. The outfall pipe and bulkhead are in disrepair.

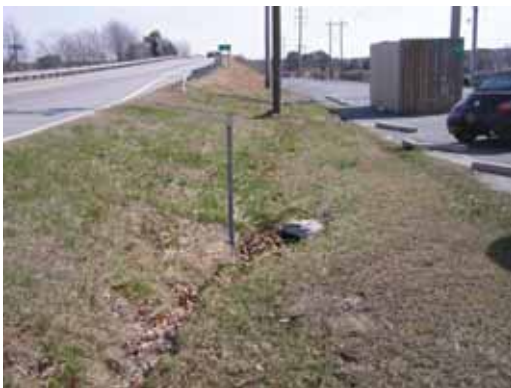
Photo 70

OAK 1 is a storm drain outfall directly into Oak Creek. It receives runoff from a portion of the Rt. 33 roadside ditch and the boat ramp's parking lot (P069 - P071).

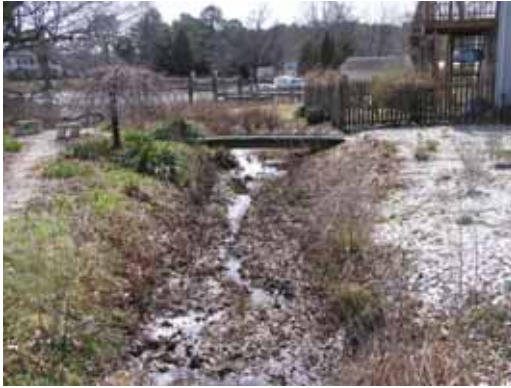
Photo 78

OAK 3 is a 270' long tidal channel that receives concentrated runoff from Back Street and the northern portion of Station Road. The channel bottom has no vegetation, but is heavily vegetated on its side slopes. (P077 - P079A).

The configuration of OAK 3 is similar to that of OAK 4, where a wide drainage channel discharges into a mud flat of tidal waters. The difference is that OAK 3 has a 95% smaller upland drainage area than OAK 4. Thus is the reason why OAK 3 is the fifth recommend priority for project retrofit within Newcomb. The residents on both sides of the tidal channel grow and promote vegetation on the channel side slopes (*Photo 78A*). The vegetation along the channel is very stable and healthy. Although OAK 3 has a smaller drainage area, the concept plan is similar to OAK 4. The result is a larger percentage of upland pollutants can be treated with the proposed improvements. A series of three stone check dams are proposed in the channel with a Submerged Gravel Wetland constructed in between the dams. Also similar to OAK 4, a living shoreline would be constructed in the tidal area downstream of the channel (see *Shoreline Improvement Recommendations*). **Exhibit 12** shows a conceptual plan view and profile of OAK 3.

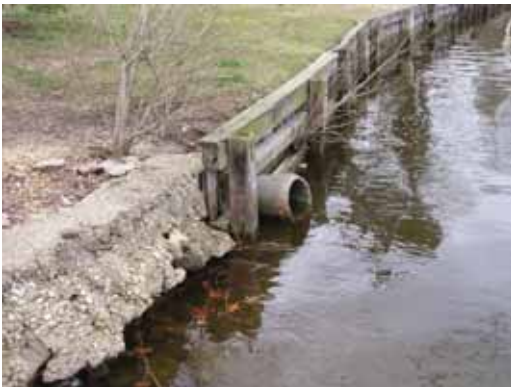
Photo 103

OAK 5 is an outfall culvert that receives runoff from River Road. Two culvert pipes and a roadside swale drain towards the outfall culvert. Although the downstream of the pipe was identified, the upstream side was not visible (P103 - P104). The outfall pipe discharges through a deteriorated timber bulkhead (P105) where significant washout is evident (Photo 105A). In observing the elevations of the pipe's downstream invert compared to the estimated upstream invert, it appears the pipe has a negative slope. Outfall pipe and bulkhead are in disrepair.

<p>Photos: W63 – W67</p> <p>Remarks: Aged bulkhead in need of replacement. Openings between timber sheeting boards evident. At time of investigation, water was draining from hole in bulkhead (shown in picture). Pipe visible in hole (Photo 67). OAK 5 daylights through bulkhead. Area behind OAK 5 is washed out (Photo 103 & 105A).</p>					
9	265'	Natural - Vegetation	Moderately Unstable

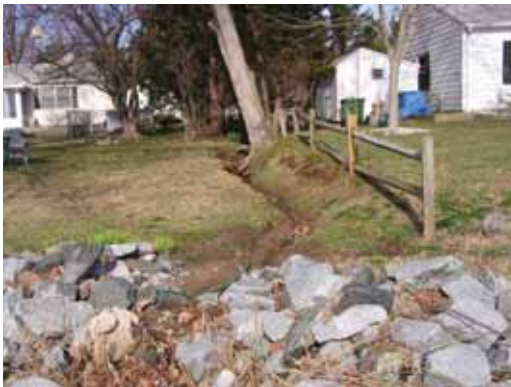
Photo W10

Oak-9 is a naturally created v-ditch along a property line due to erosion (PW10 - PW13).

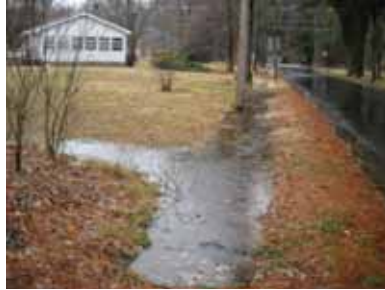
Station Road, Facing Southwest

During the course of gathering information for this study, residents of Newcomb were invited to provide feedback on the conditions of the Village, specifically any problem areas of flooding or erosion. A majority of the residents interviewed mentioned the biggest problem is the flooding that occurs at the intersection of Station Road and Royal Oak Road. There are roadside ditches on both sides of the two roads; however, the problem occurs, according to the residents, in the downstream ditch along Royal Oak Road. There is a residence located 190' to the north where their driveway culvert is clogged. This blocked culvert causes backup to the intersection and further up Station and Royal Oak Road. The residents state that flooding regularly encroaches the road, creating a driving hazard. One resident, Mrs. Julie Imirie, stated the problem causes a residual effect of flooding her property. This roadside ditch (on the northbound side) receives runoff from as far south as Acorn Road. In all, the area draining to this roadside ditch is roughly 17 acres (DA14 and DA17). The 2-year storm produces approximately 12.8 cfs. If the roadside ditch was free and clear of debris, it would be able to contain this flowrate with a peak velocity of 2.4 feet/second. The following are pictures provided by Ms. Imirie and AMA.

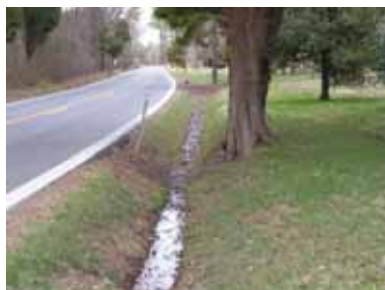
*Photo 119 - Royal Oak Road, Northwest
(Note Blocked Culvert Downstream)*

Many residents also stated that the County should regularly maintain the roadside ditches removing leaves and sediments. As previously mentioned, most of the driveway culverts are clogged up to 75%. The residents state if the culverts were clear, the drainage system within Newcomb would probably work sufficiently.

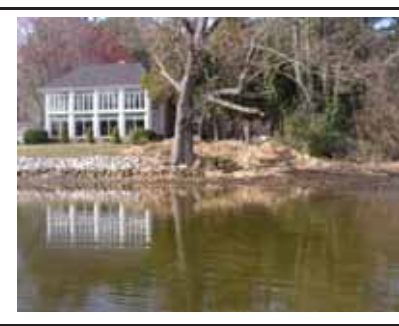
<p>Photos: W35, W38</p> <p>Remarks: Combination of timber bulkhead and stone revetment protecting single property.</p>				
5	200'	Natural - Floodplain	Stable

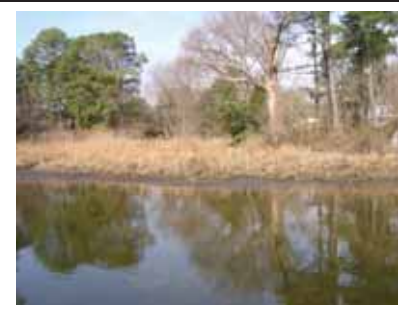
<p>Photos: W36 – W37, W39 – W45</p> <p>Remarks: Natural floodplain area (OAK 7).</p>				
6	685'	Stone Revetment	Stable

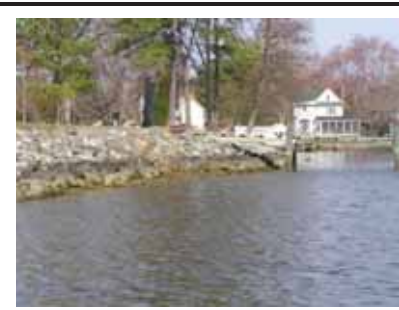
<p>Photos: W46 – W54</p> <p>Remarks: Stone revetment for protecting two properties. Storm drain pipe daylights through revetment (Photo W48). Upstream end of pipe unknown. No erosion evident. Apparent fill outboard of revetment for approximately 125' (Photo W49).</p>

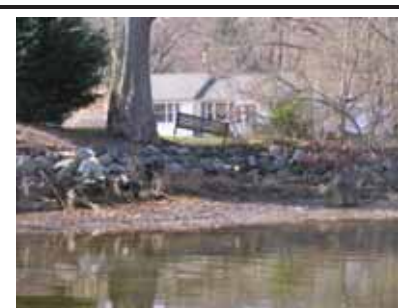
Photo 62

<p>Photos: W55 – W62</p> <p>Remarks: Minor stone revetment that is non-linear and non-uniform in height and width. Revetment area mostly stable. Last 30' of revetment is concrete rubble in disrepair (Photo 62). Undercutting of rubble revetment is evident. Rubble revetment located adjacent to OAK 5.</p>

Section 7 has approximately 30' of a concrete rubble revetment (Photo 62) that should be removed (see Table 11). Instead of replacing the revetment, a living shoreline is proposed. This could be tied into the OAK 5 project. The outfall pipe would discharge into a stone plunge pool to dissipate the velocity. Tidal wetlands would be planted behind coir fiber logs. The logs would provide protection from any minor wave activity that enters the cove. A plan view of the living shoreline is shown on **Exhibit 7**.

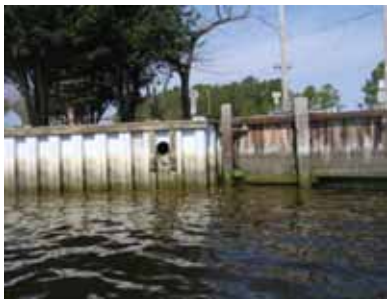
<p>Photos: W86 – W91</p> <p>Remarks: Steel then timber bulkhead on County property. Timber bulkhead continues along Rt. 33 bridge.</p>				
14	330'	Natural – Beach / Armor stone	Stable

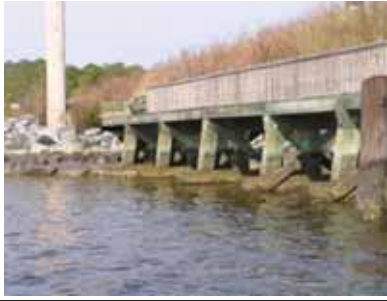
<p>Photos: W92 – W95</p> <p>Remarks: Beach located on south side of bridge. Armor stone protects bridge abutment abutment.</p>				
15	1,250'	Stone Revetment	Stable

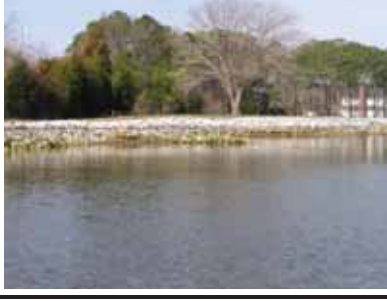
<p>Photos: W92 – W95</p> <p>Remarks: Stone revetment with high elevation (~ +6.0').</p>				
16	1,665'	Timber Bulkhead	Mostly Stable

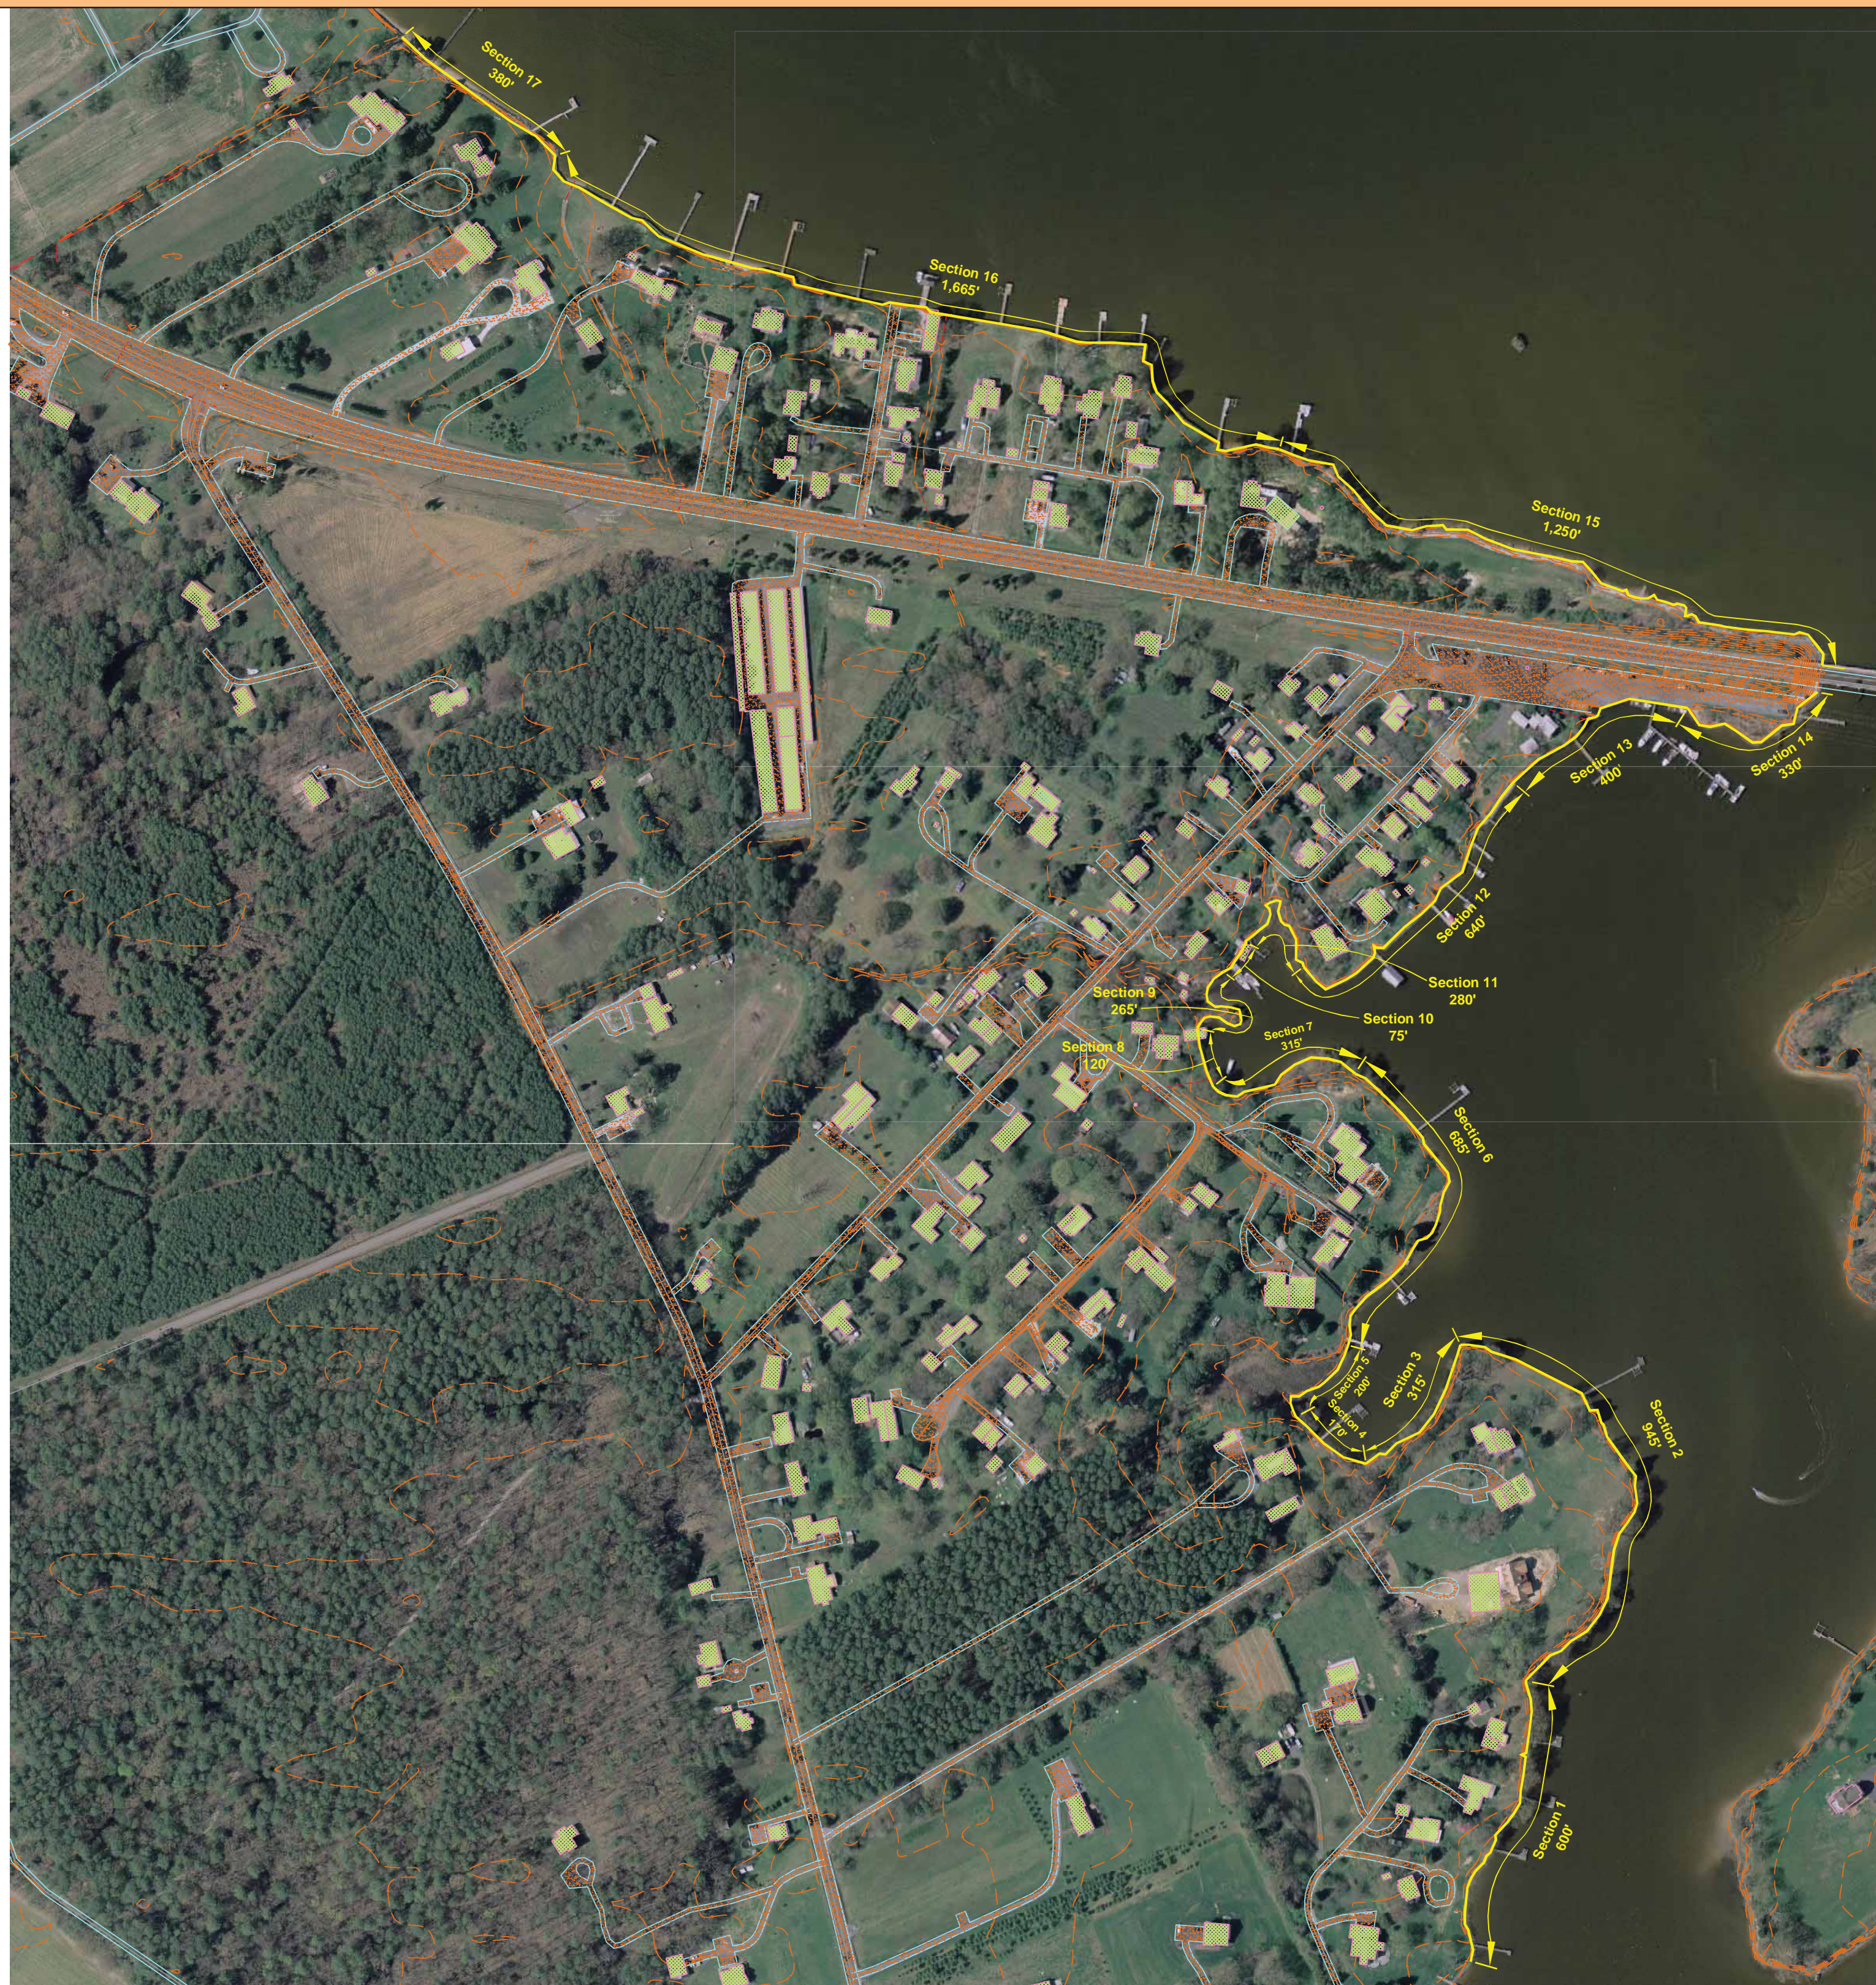
Exhibit 15

The shoreline within the Village of Newcomb is about 1.7 miles long. This includes 0.7 miles along the Miles River and 1.0 miles along Oak Creek. This area was visually inspected by boat to determine unstable areas possible causes of any unstable areas. The investigation started on the southeast edge of Newcomb, near Acorn Lane, continued under the Rt. 33 Bridge, and along the Miles River up to the limits of Newcomb. Table 11 is a summary of the shoreline investigation. Sections 1 through 14 are on located on Oak Creek and Section 15 through 17 are on the Miles River. A location map of the 17 sections is provided on **Exhibit 15**.
