COASTAL MANAGEMENT FOR TRADITIONAL VILLAGES: ROYAL OAK ASSESSMENT

Prepared by the Center for Watershed Protection, Inc.

Prepared for Talbot County Office of Planning and Zoning

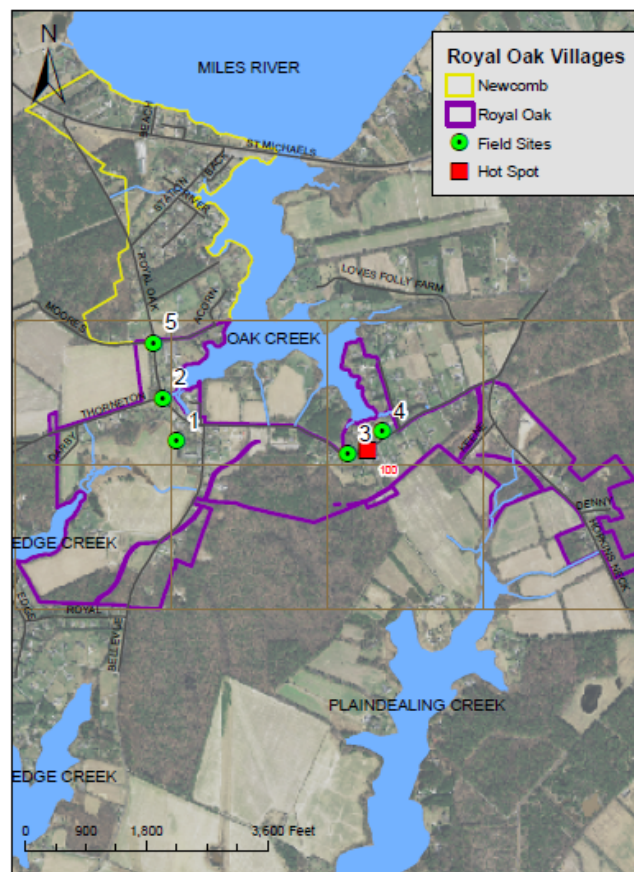
Figure 3. Field sites 1, 2, 3, 4, 5 and one Hot Spot (#100) are identified.

related to water quality noted at the five sites investigated. In fact, only one “Hot Spot” was identified and consisted of a potential sewer manhole overflow. This Hot Spot was located at Schoolhouse Lane and Royal Oak Road (see Figure 3).

A manhole that covers the pump station overflow was found in the field. This Hot Spot (Site Number 100) was located on the corner of Schoolhouse Lane and Royal Oak Road (38° 44' 28.23" N, 76° 10' 9.09" W). The site is indicated in Figure 3 with a red box. The overflow was documented (Table 7) and phoned into Talbot County Planning and Zoning Division. The City of Saint Michael's waste water treatment staff investigated this within hours of the original identification. Groundwater infiltrates the well, rises, and comes out of the manhole. It was tested that afternoon and contained no evidence of sewage contamination. This site often overflows according to the Royal Oak residents.

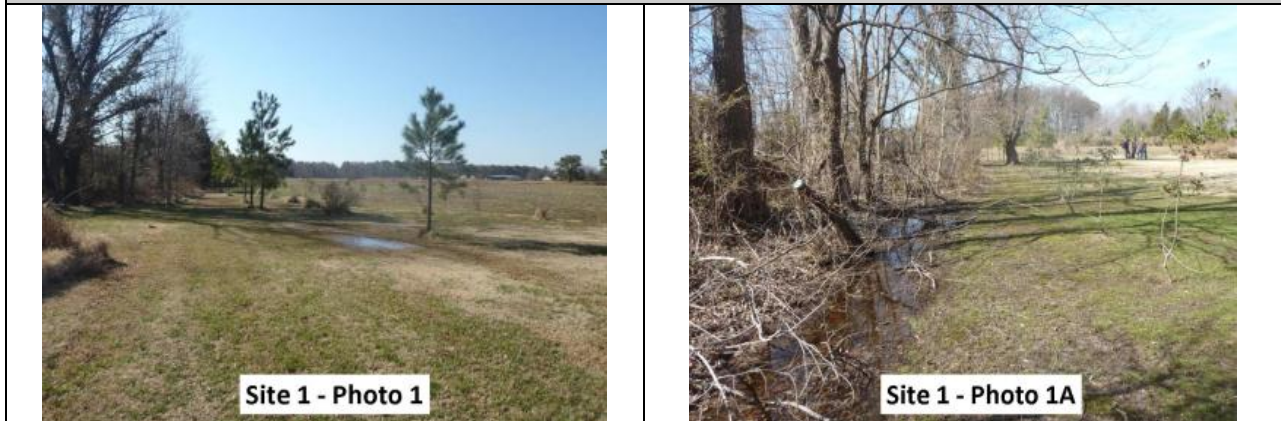
Table 2. Site 1 field photos.

1. The first starts with field runoff conveyed in a shallow depression (Photo 1A) that feeds a small ditch that runs the perimeter of the Fox property (Photo 4B) before entering a pipe system (Photo 4A).
2. The second collects the runoff from the field in small ditches immediately adjacent to the downstream side of the vegetated buffer and conveys runoff to a small pipe system (12” plastic pipe in background of Photo 3).

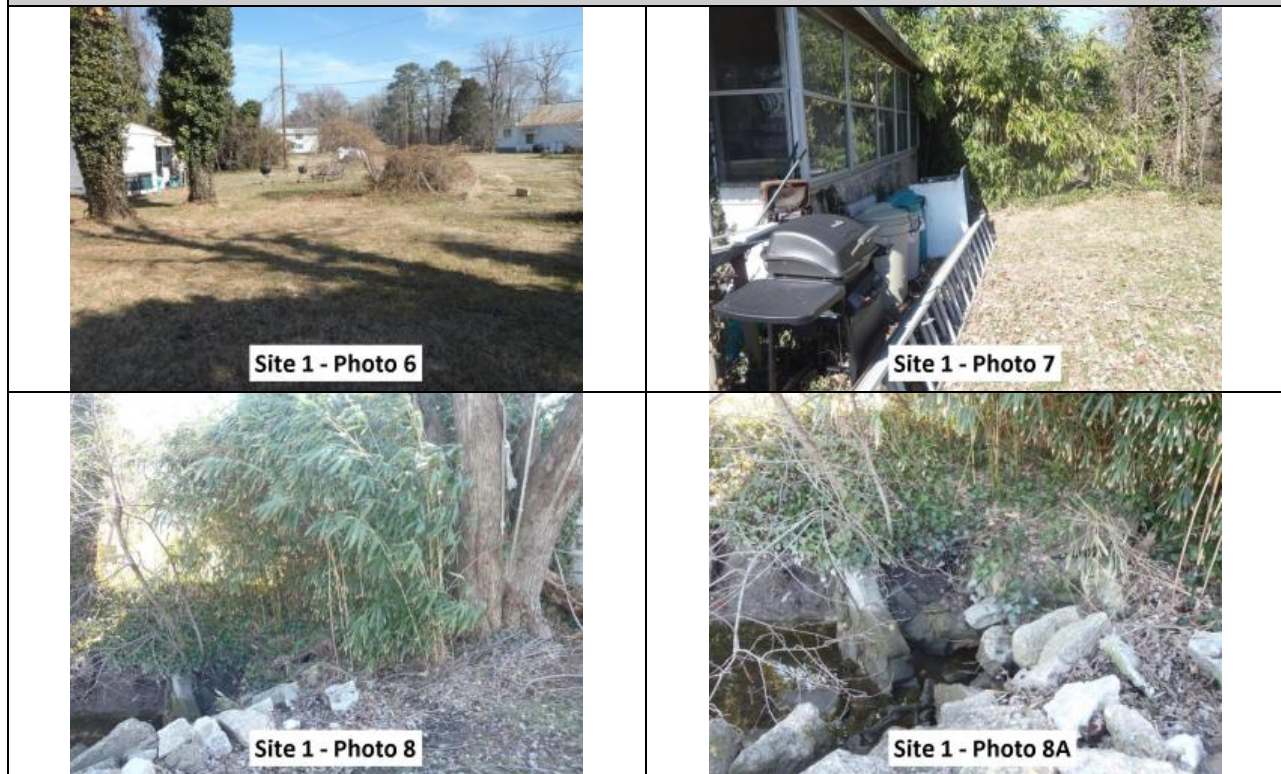
Table 2. Site 1 field photos.

- The pipe systems indicated in Photo 3 and 4A connect at 180 degrees with no maintenance access;
- The area circled in Photo 5A: this is a pipe connection of what was previously an open ditch; this area is a low point between the driveways and Royal Oak Road that routinely ponds water and the surface condition indicates that water enters the pipe system through the ground, likely carrying a significant volume of sediment into the pipe;

- The pipe system continues across Royal Oak Road and makes at least two 90 degree bends (vicinity of Photo 7) without any maintenance access, before discharging into Oak Creek. (Construction of a sewer connection from the house on the north side of Royal Oak Road indicated no conflict with, or evidence of, the drainage system; and

- The outfall of this system is shown in Photo 8 & 8A, and is in disrepair. The last pipe section has separated and fallen into Oak Creek. Rip rap and other construction debris was periodically placed around the outfall to stabilize the bank and outfall pipe.

If the system is not adequate, the drainage from the farm field can be redirected to its historic drainage pattern by leveling the low areas on the back side of the buffer that currently allow runoff to enter the residential properties. The flow should then be directed on the back side of the buffer towards the south (reversing the direction of the flow in Photo 1A) by re-establishing a short section of ditch through the field to reconnect with the main ditch system leading to the small ponds on the southern edge of the field. It is important to then establish (or re-establish) a buffer for this ditch to help maintain the efficacy of the small ponds (by filtering sediment and nutrients prior to entering the ponds).

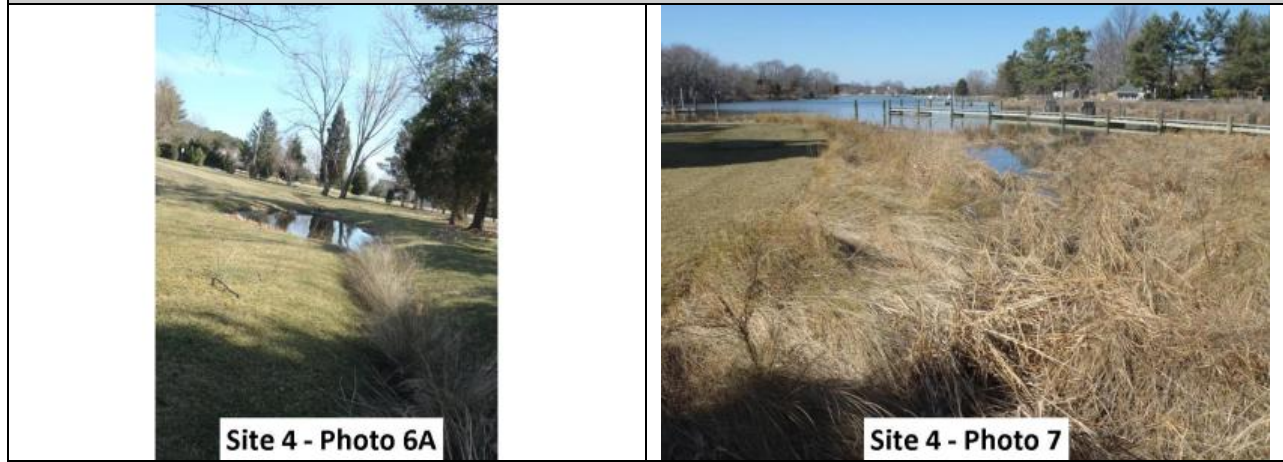
Table 5. Site 4 field photos.

The upper drainage area to the roadway cross-culvert consists of managed lawn. A broad flat swale gradually becomes more defined as it approaches the culvert (Photo 1 & 2). Typical for roadway culverts in the area, there is very little headwater depth available for the roadway cross-culvert to carry large storm flows. Therefore, the water is likely to back up during large storms and overtop the road. Also, this could occur in smaller storms (e.g., < 1 inch rainfall) if the culvert becomes clogged with leaves or debris (Photo 3).

This drainage channel has been incorporated into the private property landscaping (Photo 4), including a decorative bridge (Photo 5) and a landscape pond (Photo 6 & 6A). The landscape pond has a thick layer of organic material (leaves and bud shatter) on the pond bottom. The channel continues until below the landscape pond and then discharges to the upper finger of Oak Creek (Photo 7).

The upper portion of the channel (upgrade) – south of Royal Oak Road (Photo 1), could be retrofit with a shallow bioretention area to help reduce nutrient loads associated with managed turf in the upper drainage area, thereby improving the aesthetic conditions of the existing landscape pond. The proposed shallow bioretention area could consist of a heavy planting of herbaceous, local vegetation and include a six inch ponding area with a permeable berm. The permeable berm is proposed in lieu of an underdrain since there is no option to “daylight” an underdrain due to the flat grades.

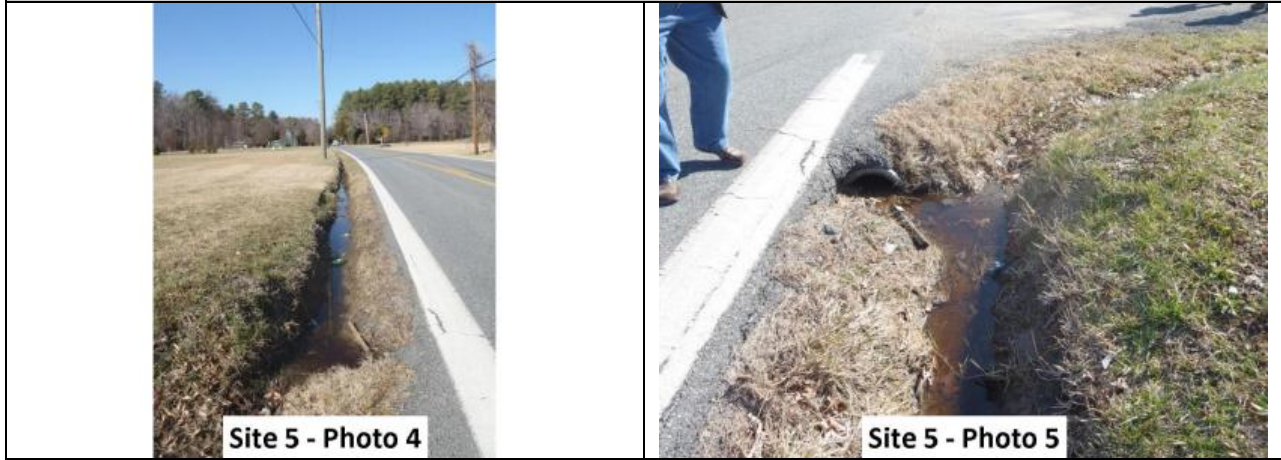
Table 6. Site 5 field photos.

The grade along Royal Oak Road is extremely flat, such that it is very difficult to determine the direction of the flow without a very accurate level. The drainage ditches at the site were all holding water. The roadside ditches appeared to contain sediment and/or organic material.
